Pooles Island Lighthouse Stabilization Project

Cultural Resource Management at Aberdeen Proving Ground

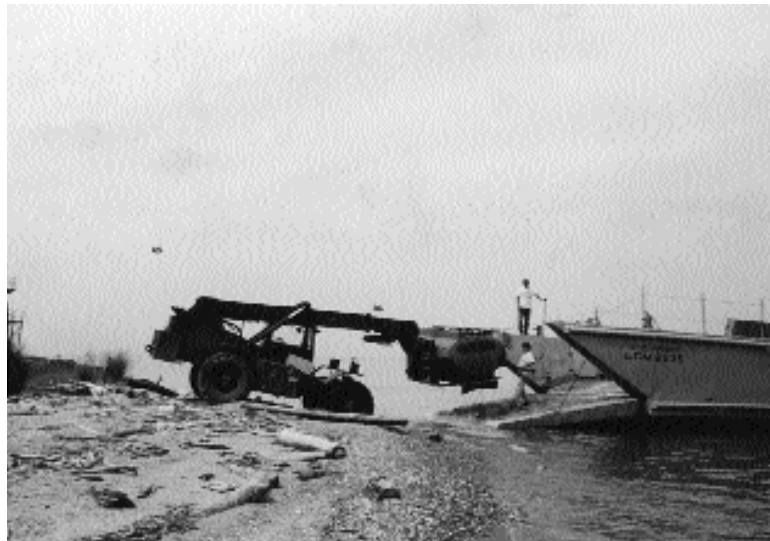
Since a pier only existed at Pooles Island in the mid-to-late 19th century, an all-terrain forklift aboard a barge with a landing ramp maneuvered onto the sandy shore to deliver all the materials and tools needed for the job. Photo courtesy Aberdeen Proving Ground.

Logistics proved to be a challenge: the lighthouse is located on an island several miles from the mainland and there is no access to electricity or fresh water. The Aberdeen Test Center (ATC) was called in to transport a 1200-gallon water tank and all the materials and tools needed for the job. Since a pier only existed at Pooles Island in the mid-to-late 19th century, an all-terrain forklift aboard a barge with a landing ramp maneuvered onto the sandy shore to deliver the items.

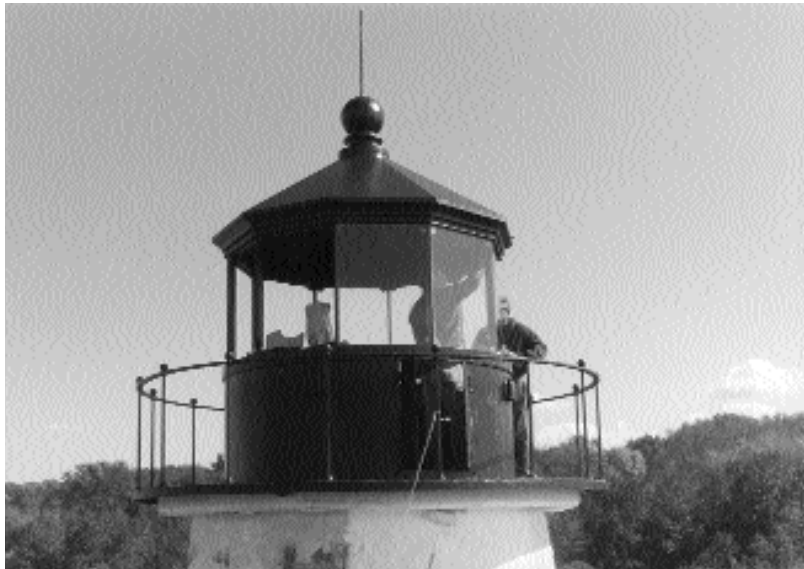
Acrylic panes were installed in the lantern with stainless steel clips and bolts that utilized the existing cast-iron lantern parapet for support.* This method ensured secure installation without alteration of the lantern itself. The existing lantern vents, the operational ventilator ball, and the unsealed acrylic panes all contribute to the positive air flow throughout the lighthouse. Courtesy Aberdeen Proving Ground.

Acrylic panes were also installed in the lantern with stainless steel clips and bolts that utilized the existing cast-iron lantern parapet for support.* This method ensured secure installation without alteration of the lantern itself. The existing lantern vents, the operational ventilator ball, and the unsealed acrylic panes all contribute to the positive air flow throughout the lighthouse.

* Use of acrylic is acceptable as a temporary protective measure; however, glass should be used as a permanent solution as acrylic breaks down with exposure to UV and salt etching.
